# Manhole Inspection Summary

Manhole # S25QQ1013MH

Insp Date: **12/28/06 12:44 PM**

**Location** Address: **4711 ROLAND AVE**

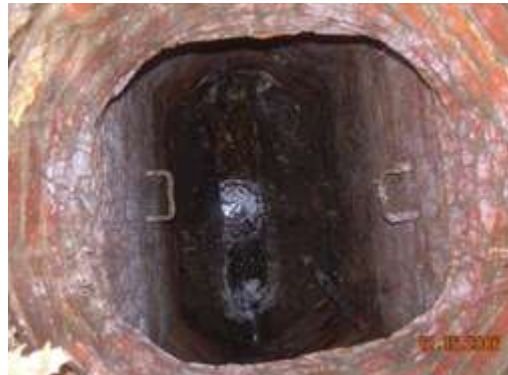
Top View

Adjustment and Barrel root intrusion and infiltration. Corroded steps. Evidence of surcharge - Bench debris. Channel

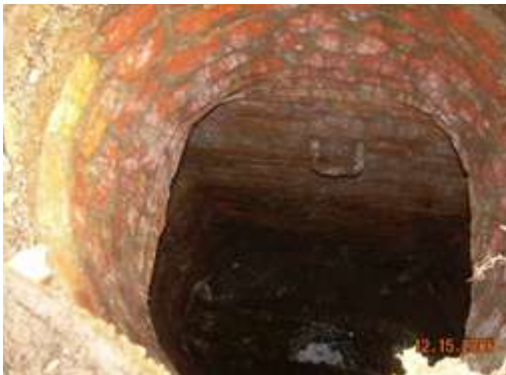
Defect

Adjustment deterioration, root intrusion and infiltration. Corbel and Barrel infiltration.

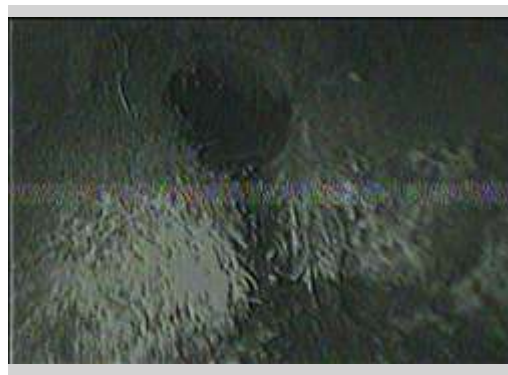
Defect

Bench and Channel root intrusion.

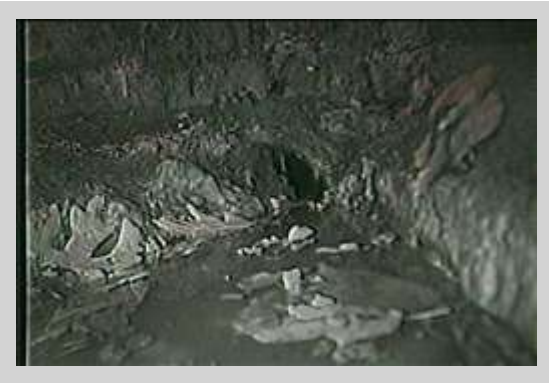
### 6 in. Circular Gravity Sewer Pipe Out @ 12 O'Clock

Barrel deterioration, root intrusion and infiltration.

Deposits: ☐ None ☒ Mud ☐ Sludge ☒ Debris ☒ Grease

Silt Depth: **3** (in.) Deposits Extent: **Heavy**

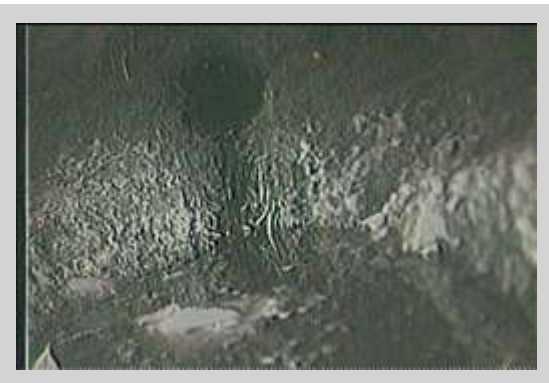
### 6 in. Circular Gravity Sewer Pipe In @ 6 O'Clock

Bench and Channel root intrusion.

Infiltration: **Evidence** Pipe Seal Cond: **Roots**
